# Case Study - Information Bulletin

## New Construction – Duct Boots

### The air leakage problem with duct boot cut-in penetration.

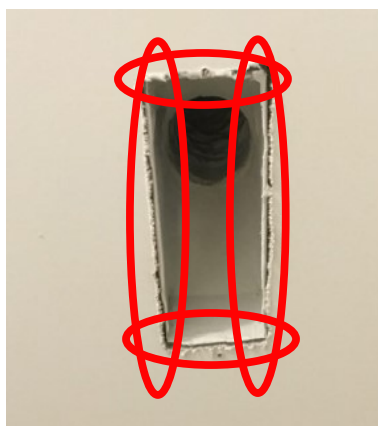
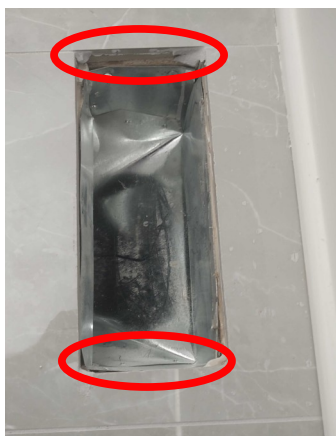
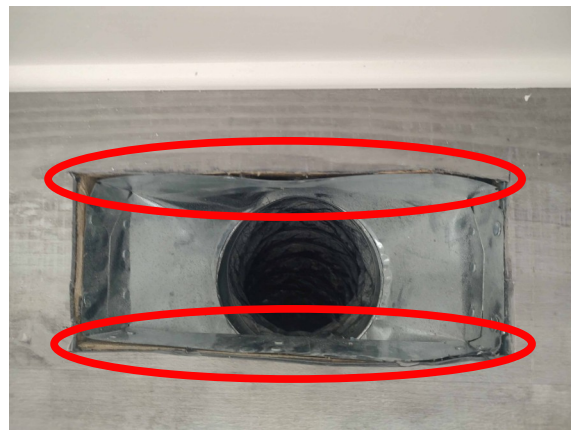
### **The Problem.....**

Most duct boot cut-in's are roughly cut out and improperly fitted. These gaps, both large and small, allow air infiltration and leakage, which lead to increased heating and cooling costs and potentially condensation and mold growth. The cut-in's below are poorly cut, improperly fitted, and have no sealant applied.

These will leak air and should have been sealed prior to the finish flooring being installed.

Roughly cut hole, improperly fitted boot, no sealant..

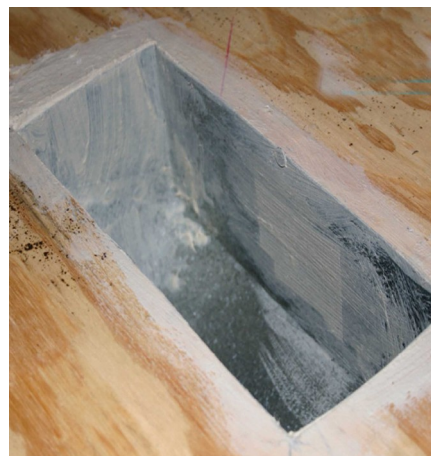
This is what a clean cut, properly fitted, and properly sealed boot cut-in should look like.
